## Quadrus 9 Office Building

### Safe Exterior Stairs at Quadrus 9 Office Building with Slip Resistant Galvanized Angles

Company: Devcon Construction

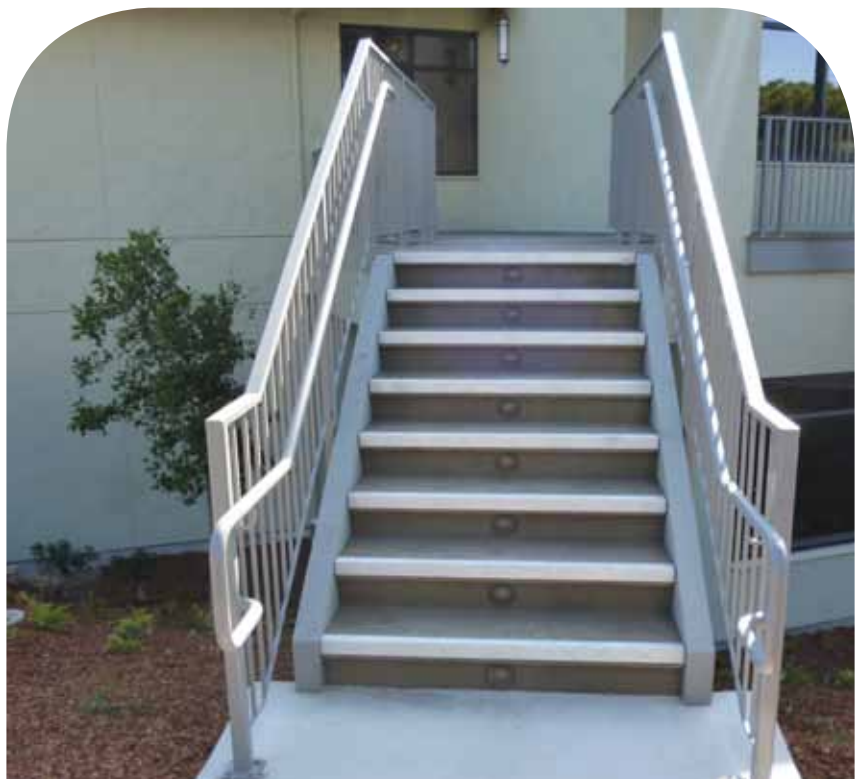
The Quadrus 9 Office Building in Menlo Park, CA had concerns for slippery conditions on exterior stairs. SlipNOT® galvanized angles were recommended as a nosing to provide slip resistant compliance for this application.

- 2" x 2" x 3/16" x 48-7/16" Grade 2 galvanized steel stair nosings
- The Quadrus 9 Office Building installed safety nosings on their exterior stairway that will stand up to the corrosive environment created by seasonal weather in a high traffic area.

Devcon Construction was awarded this job; they have used **SlipNOT®** anti skid stair nosings in the past and found its performance to be the superior choice for Stanford's Hopkins Marine Station. They recommended the **SlipNOT®** surface in a galvanized steel Grade 2; the hot-dipped galvanized finish option was selected to promote longevity by preventing corrosion. Galvanizing is performed in accordance with ASTM A123 or other appropriate specifications. **SlipNOT®** steel material can be galvanized after additional fabrication or processing. For this instance, **SlipNOT®** provided eight 2" x 2" x 3/16" x 48-7/16" steel angle nosings with a Grade 2 hot-dip galvanized finish. Detail drawings were provided to pre-fabricate countersunk holes for ease of installation into the existing stair treads upon receipt.

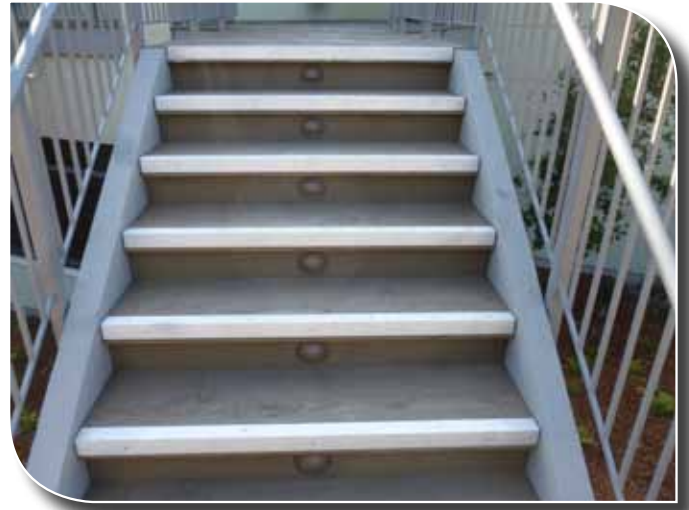
A Project Engineer at Devcon Construction Inc. reported that the nosings were ordered to be installed on the exterior stairs to meet office building's contrasting slip requirements. The Quadrus 9 Office Building now has safety nosings on the exterior stairs that will not only provide a high coefficient of friction, but also stand up to the corrosive environment created by seasonal weather in a high traffic area. As more companies analyze their safety plans, the need to provide safe entrances, egress stairs, as well as working surfaces will continue to expand; stair nosings are just one example of a retrofit solution over existing slippery walking surfaces.
