FORD DEARBORN

DEARBORN, MI

SlipNOT® Replaces Epoxy Paint on Diamond Plate for Final Assembly Line

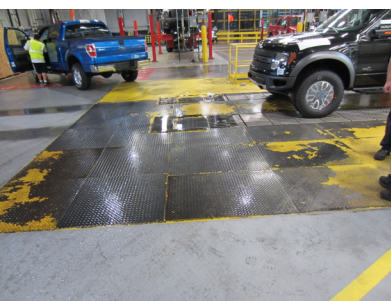
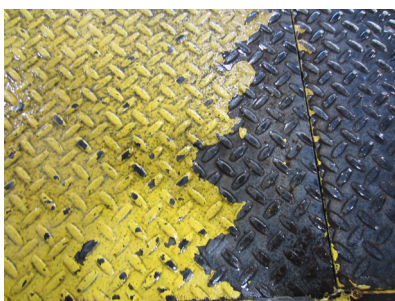
BEFORE

The Ford Engine Automobile Plant, formerly known as the Ford River Rouge Complex, was looking for a solution to slippery areas in the final assembly area of the facility. In the final assembly area the last stage trucks go through is to be washed underneath and then driven off the line. Personnel have to physically get in the truck and drive it to a lot at a quick pace. With a slippery stepping surface this could be a slip hazard.

The maintenance leader was familiar with SlipNOT® products and suggested contacting a sales representative to inquire if they could visit for an estimate. In the past epoxy was used on top of diamond plate, which worked but for a short amount of time, until it began chipping.

The plant was preparing for a small shut down and that was the perfect time for the customer to remove the existing diamond plate and ship it to SlipNOT® for the steel coating to be applied. SlipNOT® received the plates, blasted and coated the plates, and then sent them back to Ford to be installed within a day turnaround time. The plates were then painted yellow for added visibility and safety.

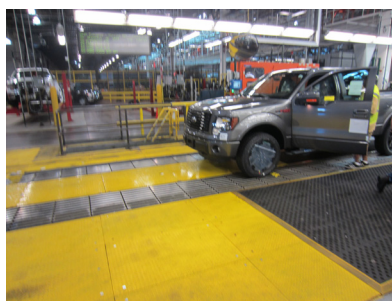
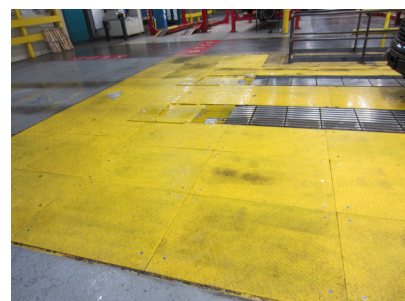
AFTER

SlipNOT® created a permanent solution to the rinse off area of the final assembly line. SlipNOT® is bonded at over 4,000 psi so it will not chip or flake off like temporary products. The plates provide a slip resistant, durable surface for high traffic environments and will provide safety for years to come. The next time our sales rep was out visiting several employees indicated they were happy with the new products. SlipNOT® has worked to ensure the safety of drivers in wet conditions by providing stable footing.
