NEWMONT

Galvanized Flattened Expanded Metal Retrofitted Over Grating Stairs at Newmont

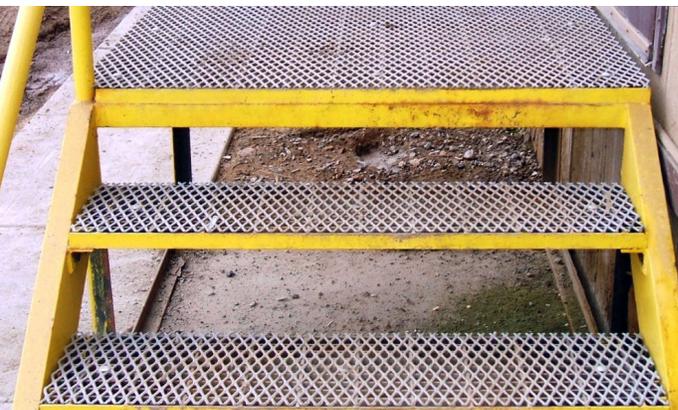
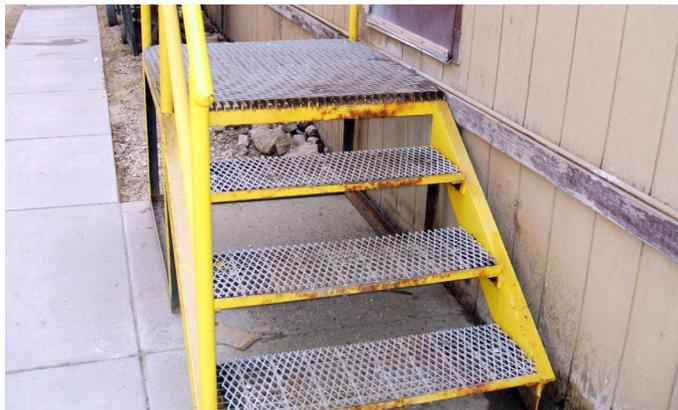
Newmont Mining Corporation needed a quick and durable retrofit solution for their existing slippery metal grating stairs. Slips, trips and falls frequently occurred on the metal grating stairs during the snowy winter weather and had proven to be unsafe. The metal grating stairs were installed in front of their office buildings and employees were constantly struggling to keep their footing due to the slippery grating surface. Newmont Mining Corporation was looking for a easy retrofit solution to place over the existing grating stairs.

Newmont Mining Corporation ordered twelve (12) pieces of customized 3/4#9 flattened expanded metal retrofit stair treads. The retrofit expanded metal treads were ordered in customized sizes of 11" x 44" and 11" x 36".

The expanded metal retrofit stair treads were chosen for this application because of their easy installation and instant safety. The expanded metal retrofit stair treads also provide easy passage of snow, light, air, water and moisture just as the original existing bar grating did for them in the past while providing a 100% slip resistant coating allowing for 100% shoe to surface contact.

SlipNOT® Metal Safety Flooring has a variety of slip resistant coating options for all metal substrates. In this case, Grade 3 (Coarse) was chosen because of the extreme durability and coverage it presents. Grade 3 (Coarse) is often

The galvanized steel retrofit expanded metal stair treads installed with ease and solved the slippery surfaces with minimal effort. Not only did the SlipNOT® retrofit expanded metal treads provide instant safety once installed, they were cost efficient and allowed for the existing grating treads to maintain in place without complete replacement or removal.
