FAGE

SlipNOT[®]'s Stainless Steel Stair Treads Welded Over Slippery Diamond Plate

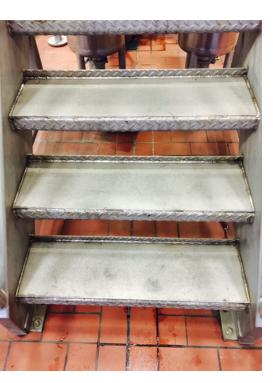
There was an existing diamond plate staircase at the raw milk receiving bay that would get wet due to the hosing down of the delivery trucks. The water being tracked in by the bottom of workers boots made the diamond plate very slippery and a safety hazard.

A local engineering firm contacted *Slip*NOT[®] for a high traction solution to the slick diamond plate. After reviewing project details, *Slip*NOT[®] provided (4) 3/16" x 8-1/2" x 30" & (1) 3/16" x 24" x 30" 304 Grade 2 stainless steel plates that were retrofitted over the existing treads by welding. NSF registered for use in food processing facilities, *Slip*NOT[®] stainless steel products provide a chemical/corrosion resistant surface that is hygienic, sanitary, and durable.
