Galvanized Steel Plate and Stair Treads Installed at Vermont Electric Power Company

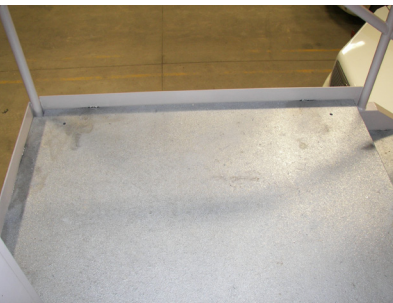
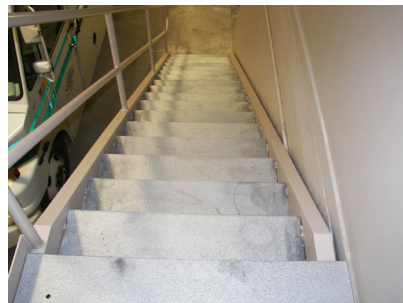
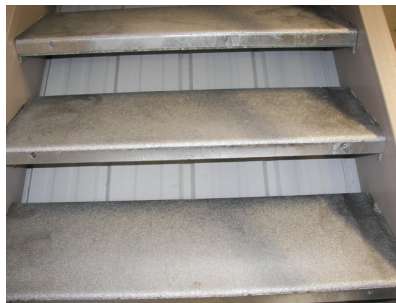
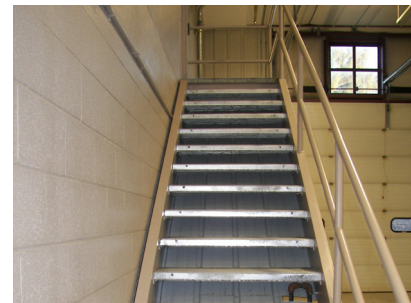
Vermont Electric Power Company (VELCO) began in 1956, creating the nation's first statewide transmission only company. VELCO currently manages 732 miles of transmission lines, 53 substations, 13,000 acres of rights-of-way, fiber optic communication networks and equipment that enables interconnected operations. VELCO is now the country's fastest growing transmission company, ensuring continued access to reliable, climate friendly power technology. While providing preeminent service, VELCO also focuses on employee safety. A facilities supervisor contacted SlipNOT® in regards to their existing slippery grating stair treads and platform. The supervisor said due to a change of use in the area, the stair treads became a safety concern.

Once VELCO gave SlipNOT® the staircase and platform specifications, SlipNOT® provided 3/16" x 12" x 36-3/8" Grade 2 galvanized steel stair treads and a 3/16" x 41-3/4" x 60" Grade 2 galvanized steel plate. Galvanized steel is durable, corrosion resistant and has a bond strength of at least 4,000 psi and a surface hardness between 55 – 63 on the Rockwell "C" scale. The galvanized steel products were easily tack welded to the existing grating treads, which was accomplished in no time.

SlipNOT® exceeded the expectations of VELCO. Once the galvanized steel plate stair treads and plate were installed, VELCO no longer had a safety concern. Employees were more productive knowing they have a slip resistant surface rather than bar grating and now have high traction in all directions.
